USAAEFA PROJECT NO. 79-13

# CLIMATIC LABORATORY EVALUATION YCH-47D HELICOPTER

FINAL REPORT

AUGUST 1981

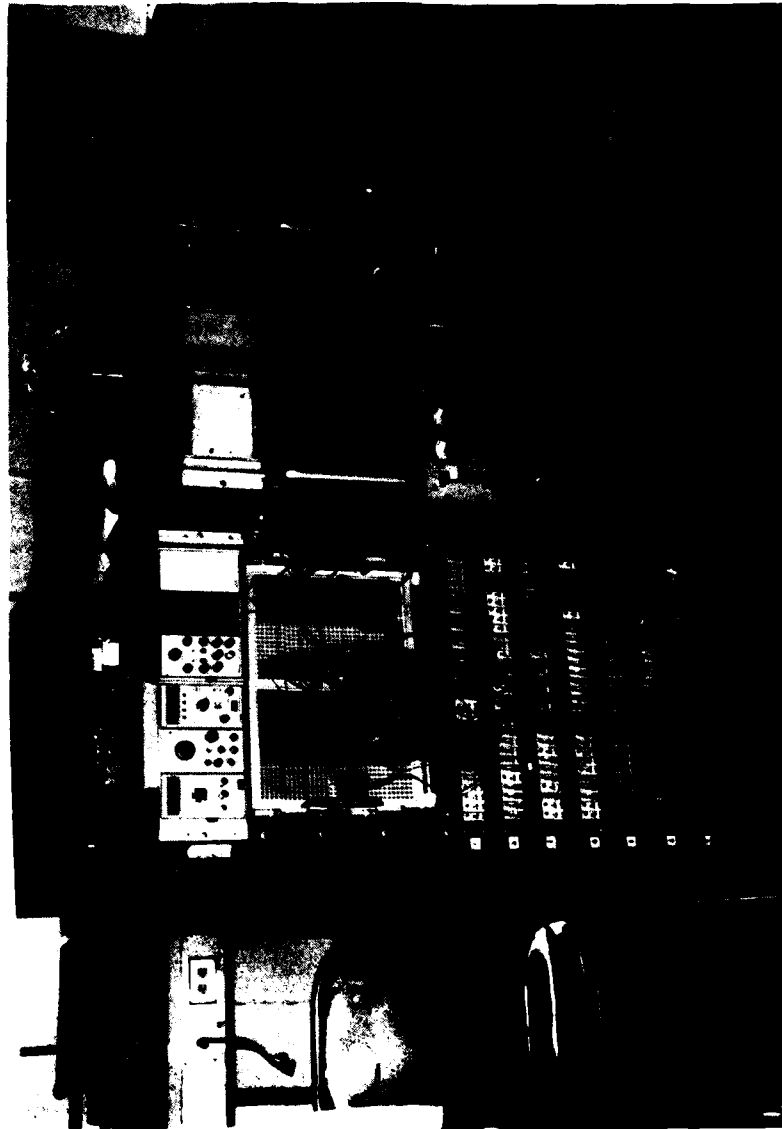
Photo 1. Instrumentation Package

2. The following calibrated test instrumentation was installed on the aircraft. The parameters annotated in the display column by CRT (CRT display furnished by the Climatic Laboratory) were displayed during the tests and retained as desired on permanent copy. All parameters were recorded on magnetic tape. The four CRT data presentations utilized on this program are included in table 1.
